PROJECT PROFILE

Lindenmeyr Monroe Warehouse

Industrial Concrete Floor Repair

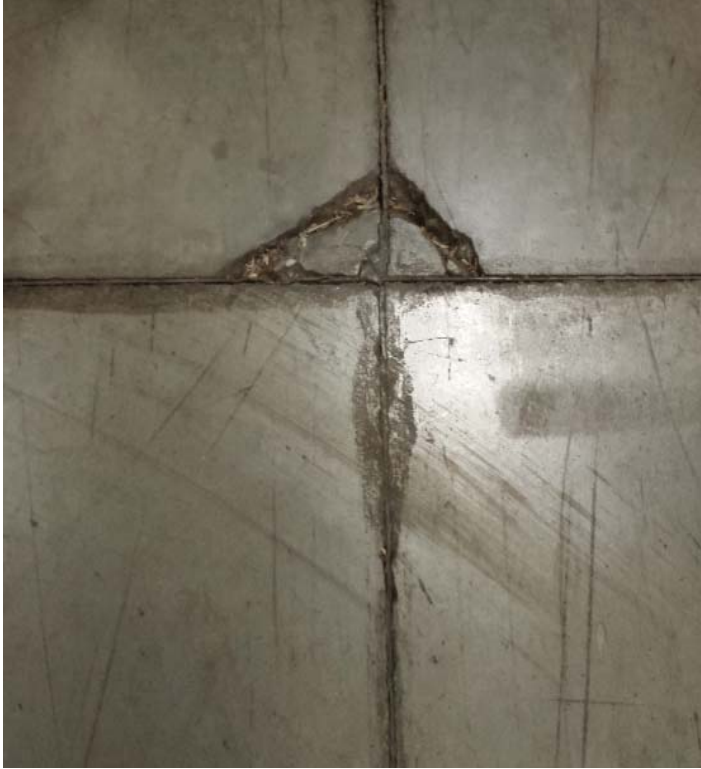
BEFORE - Geological issues below the slab and heavy forklift traffic cause deflection and excessive floor joint damage.

Lindenmeyr Monroe, one of the largest fine paper merchants in the U.S., was experiencing floor joint damage in their 78,000+ square feet warehouse in Mount Joy, PA. Geological issues below grade and heavy fork lift traffic above grade caused the floors to deflect and encounter some excessive floor joint damage.

The Witmer Group team was brought in to complete a thorough evaluation of the damaged floor slab and to remedy the situation. A progressive solution was necessary to repair the existing damage and to stabilize the floors for the future rigors of below grade and above grade stress. We combined multiple types of floor joint repair methods along with floor slab stabilization techniques. One of the floor joint repair methods included the use of epoxy mortars to rebuild the edges of the floor joints, preparing them for new joint fillers. To address the deflection of the concrete floor slabs our team used a high density foam injection technique.

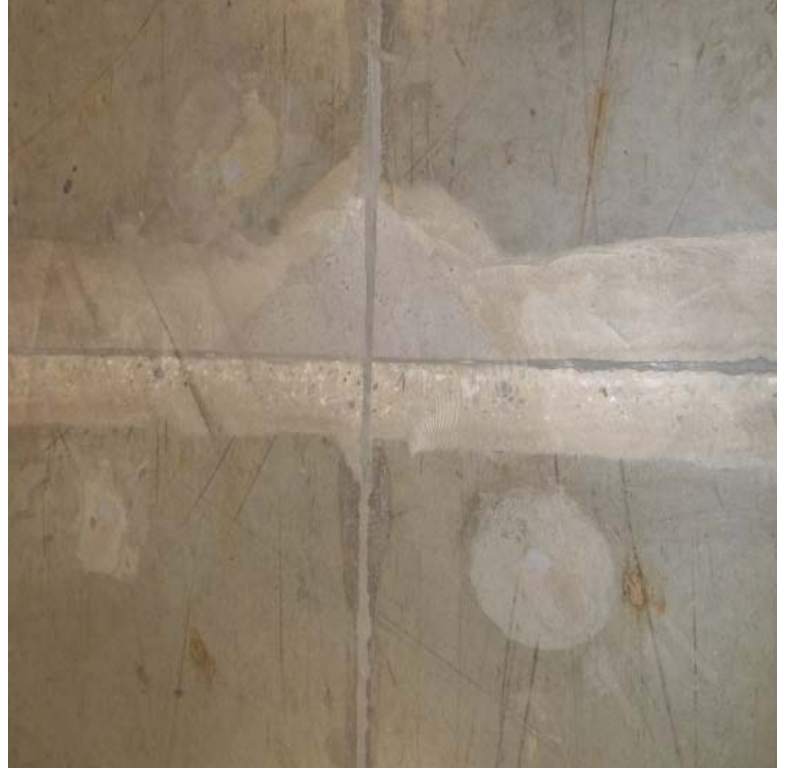
AFTER - With multiple types of floor joint repair methods, floor slab stabilization techniques and high density foam injection.
