SEALANT, WATERPROOFING & RESTORATION INSTITUTE • WINTER 2017 • 39.1

## RESTORING BURNSIDE BRIDGE

# RESTORATION OF BURNSIDE BRIDGE

By Polly Raine

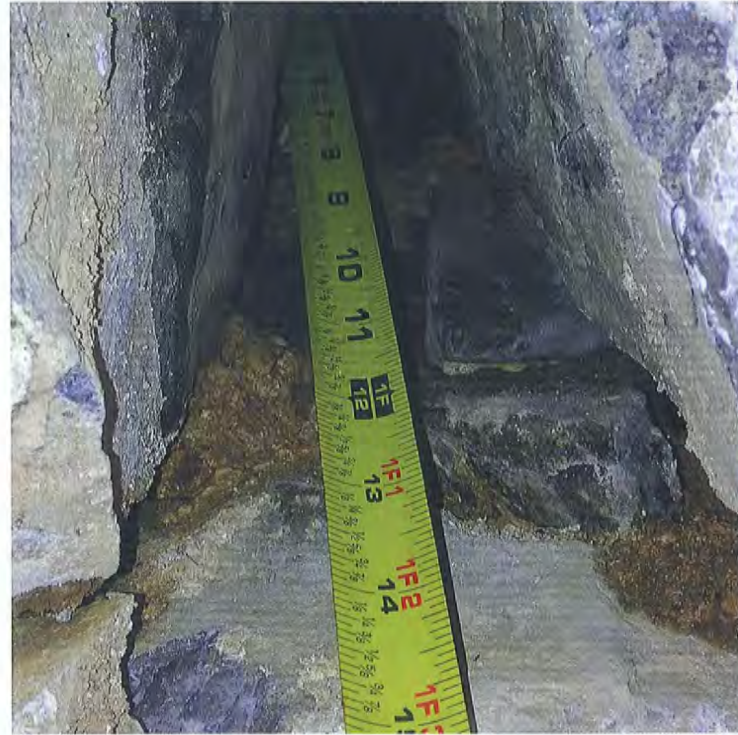
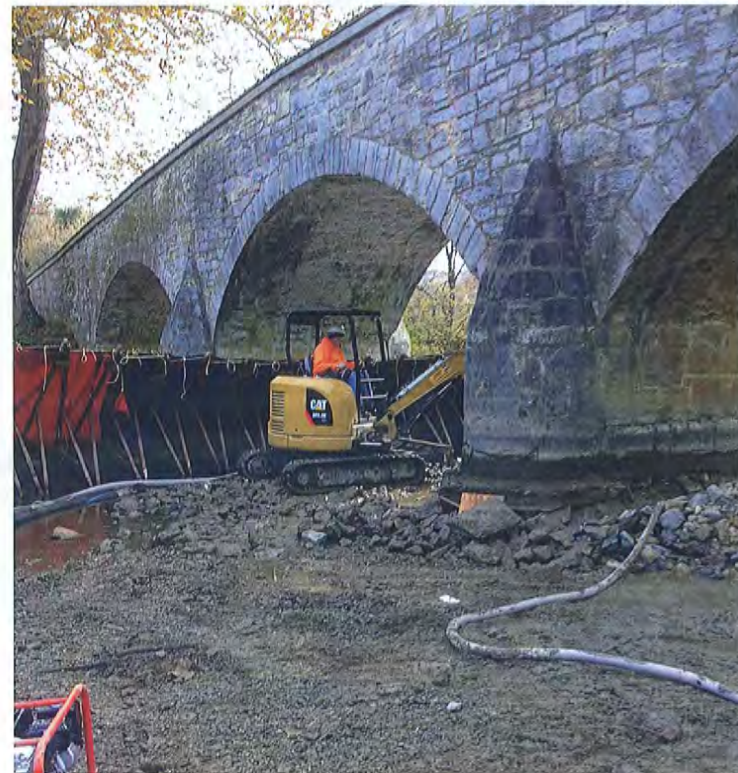
Water in Antietam Creek flows at a minimum of 200 cubic ft/second, up to 5ft. deep in portions. The Witmer Group's contract required that the work be performed dry, not only because materials demanded it, but out of safety concerns for those performing the work. Step one was to build coffer dams to partially divert water (dams were relocated as work progressed). A metal skeleton was built, then draped with waterproof poly and secured with sandbags.

The initial design allowed for water seepage through the sediment, requiring the addition of seven water pumps. The solution included two large pumps for substantial standing water, along with up to five small pumps to remove puddled water. (The pumps continued to prove beneficial later in the project, being reversed-out to provide high pressure washing in prep for repointing, and to aid in cleaning.)

Coffer dams were a necessity, and for the most part successful at diverting creek water. After initial adjustments, they remained intact with one exception - the winter of 2015/16 saw a heavy local storm that deposited 3 feet of snow. Water rose rapidly upon snow melt, flowing at a rate of 1,000 cubic feet/second overtaking the dam. Work was delayed for one month while waters receded and work areas dried.

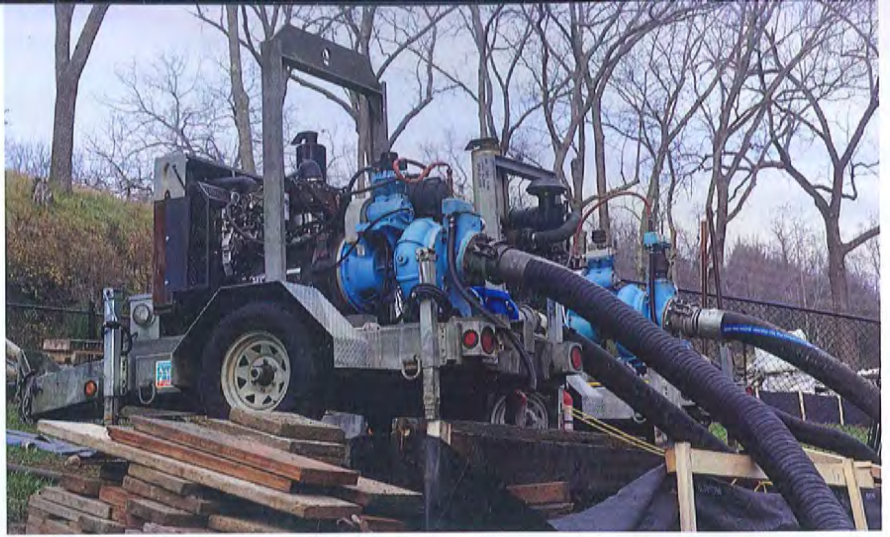
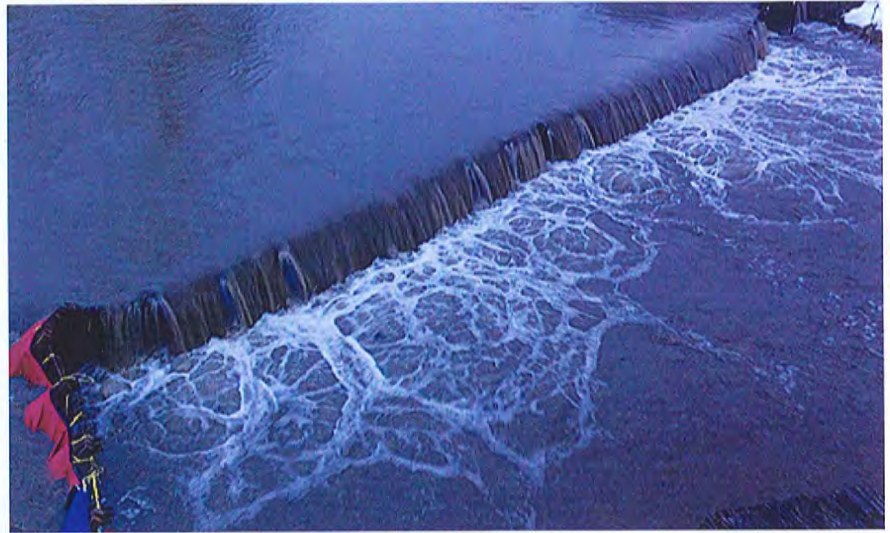
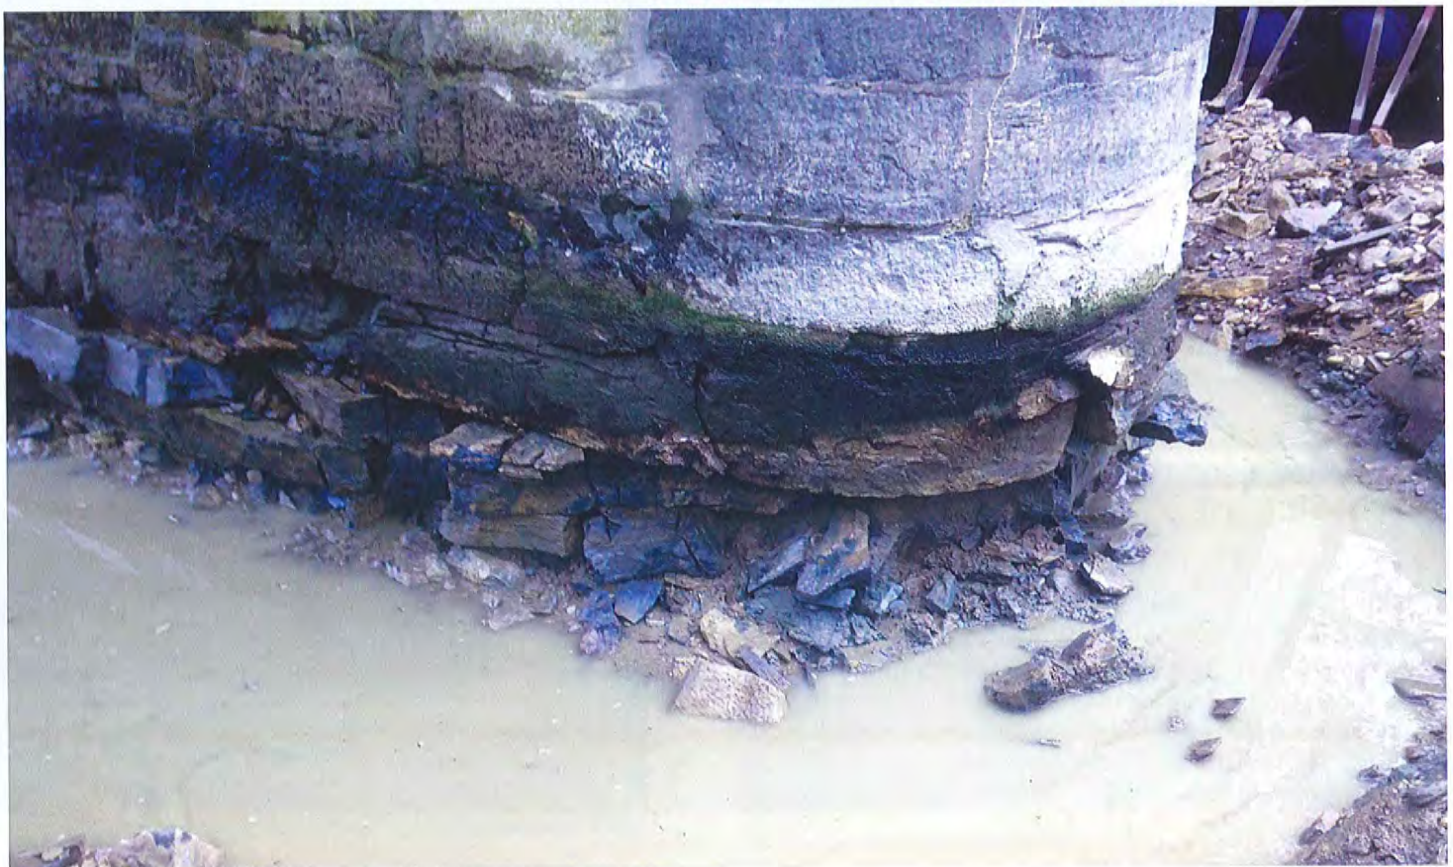
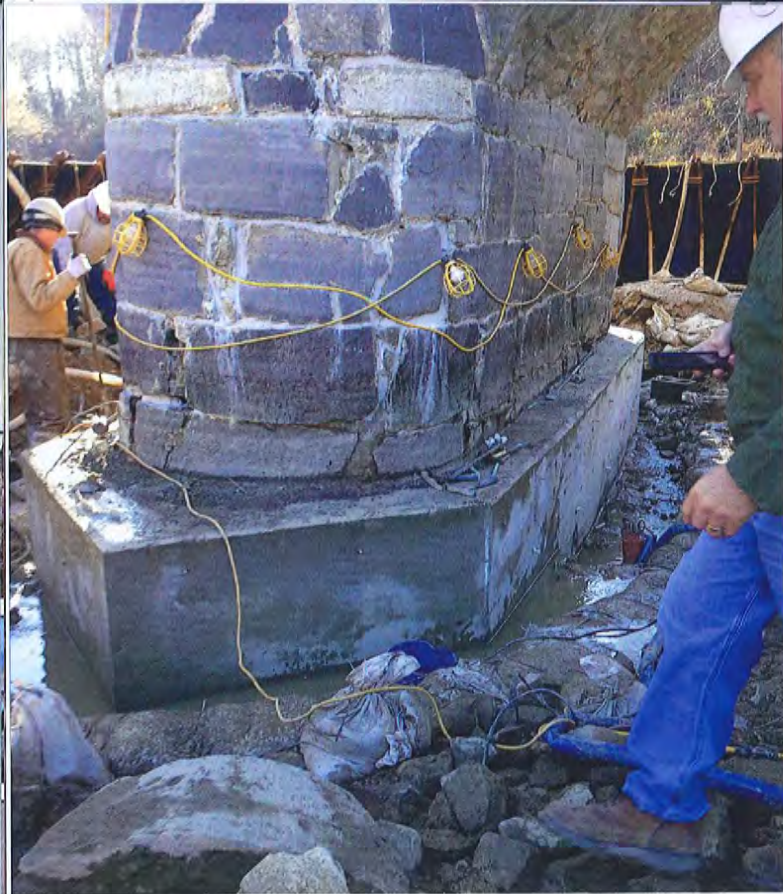
Once creek beds were dry and the footings fully exposed, the crew was quick to learn the supports had severely deteriorated, requiring underpinning before moving forward. Sandbags were installed to line trenches dug around

the piers. Once pumped dry, footing extents were wrapped in epoxy-coated rebar followed by forms. Witmer's crew poured new concrete footings for both piers – 8 cubic yards of concrete for each.

Some careful forethought allowed for predetermination of the layouts for future scaffold while the ground was dry. Bases were poured in a grid pattern, 1 foot deep into the sediment, onto which scaffold would be securely erected months later when the dams were removed (concrete scaffold bases were likewise removed when the job was complete).

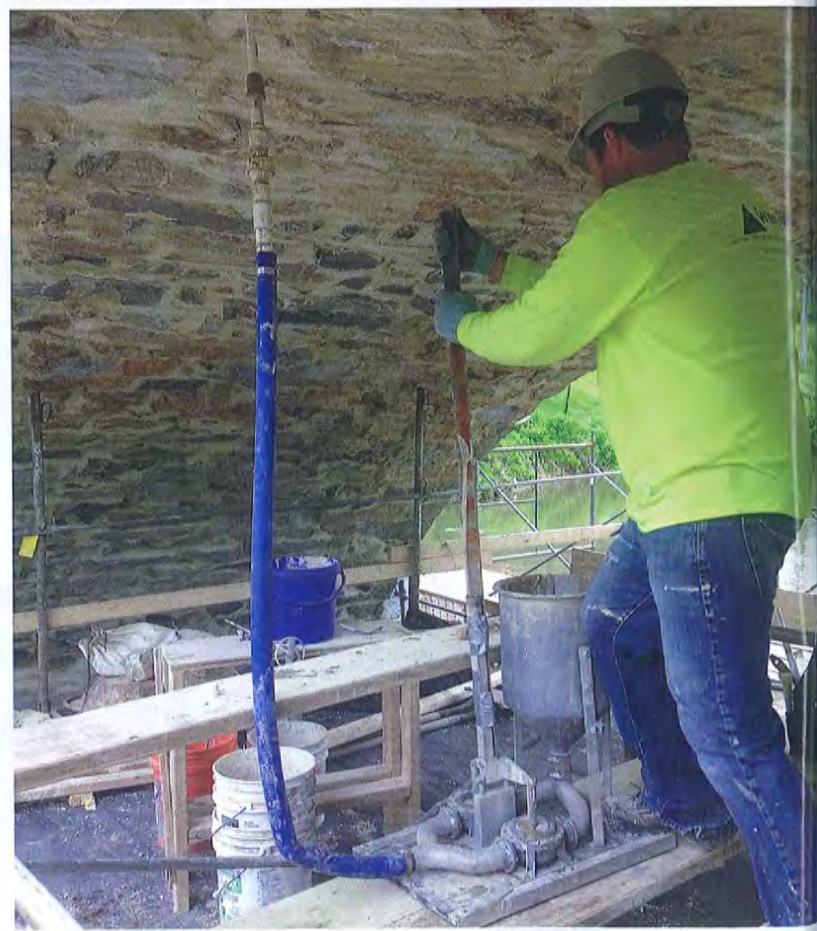
The concrete slab (which rested on the piers below) had been removed in order to add one-inch threaded stainless steel tie rods for additional structural

support. New slab was poured to encase the new and existing tie rods. With new footings, flowable fill stabilizing every crevasse, and the added tie rods, the piers' long-term structural integrity was assured.

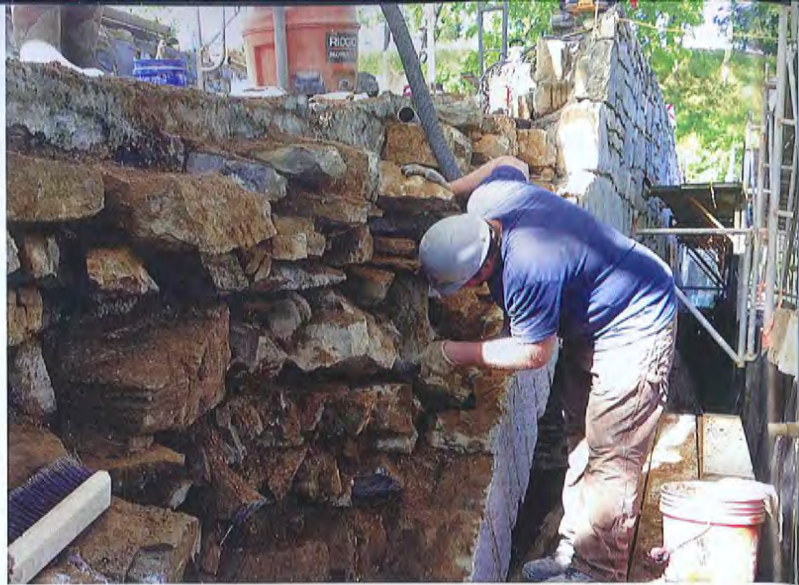
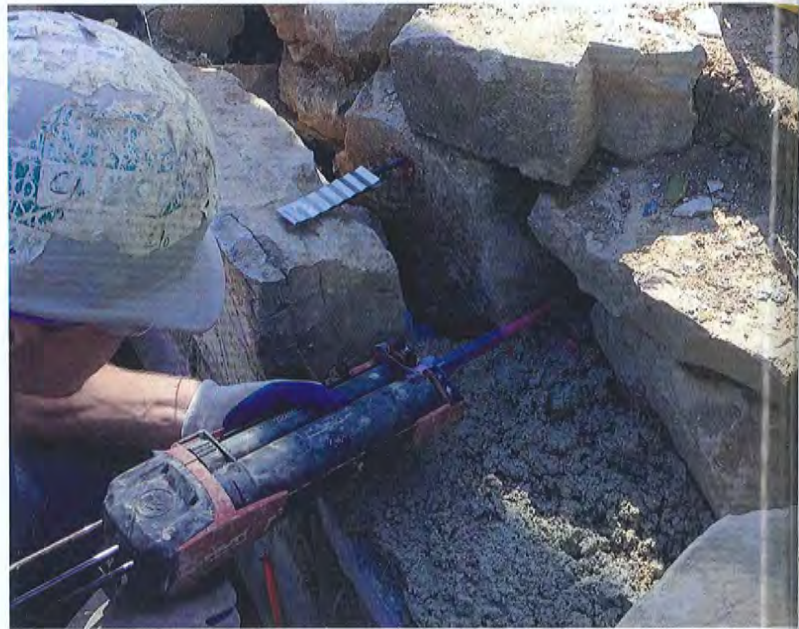
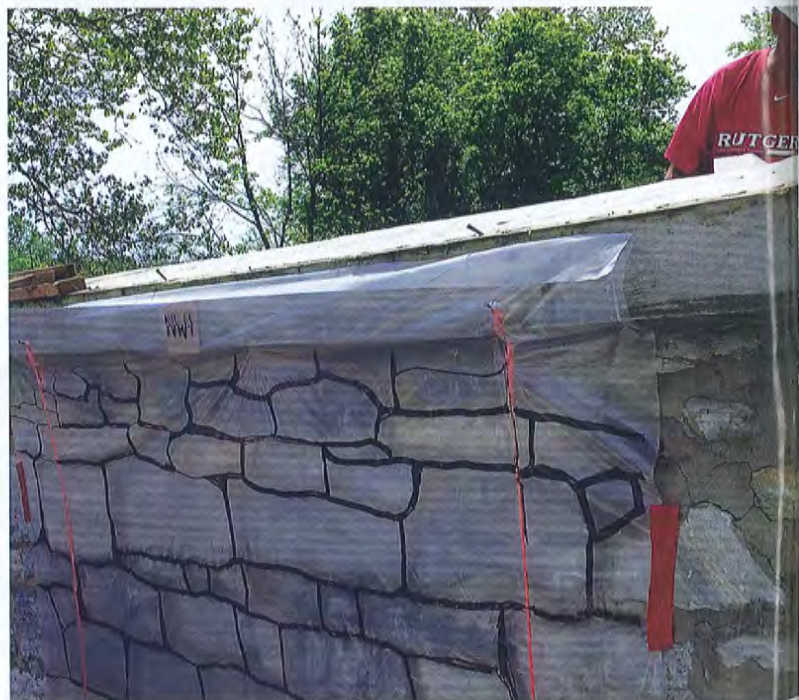
The crew hung poly sheets, outlining each stone, numbering character stones on both map and stone faces. A duplicate copy of the map was created and laid on the ground, onto which stones that had been

extracted would be temporarily placed. In some sections, walls were up to one foot out of plumb – an issue able to be corrected in the finished product.

Once sections were reconstructed and repointed, a natural lime mortar wash was added atop the side walls in preparation for a waterproof membrane, stainless steel pan flashing system, and finally a rough sawn oak system at the parapets to match the original design.
