Enola First Church of God

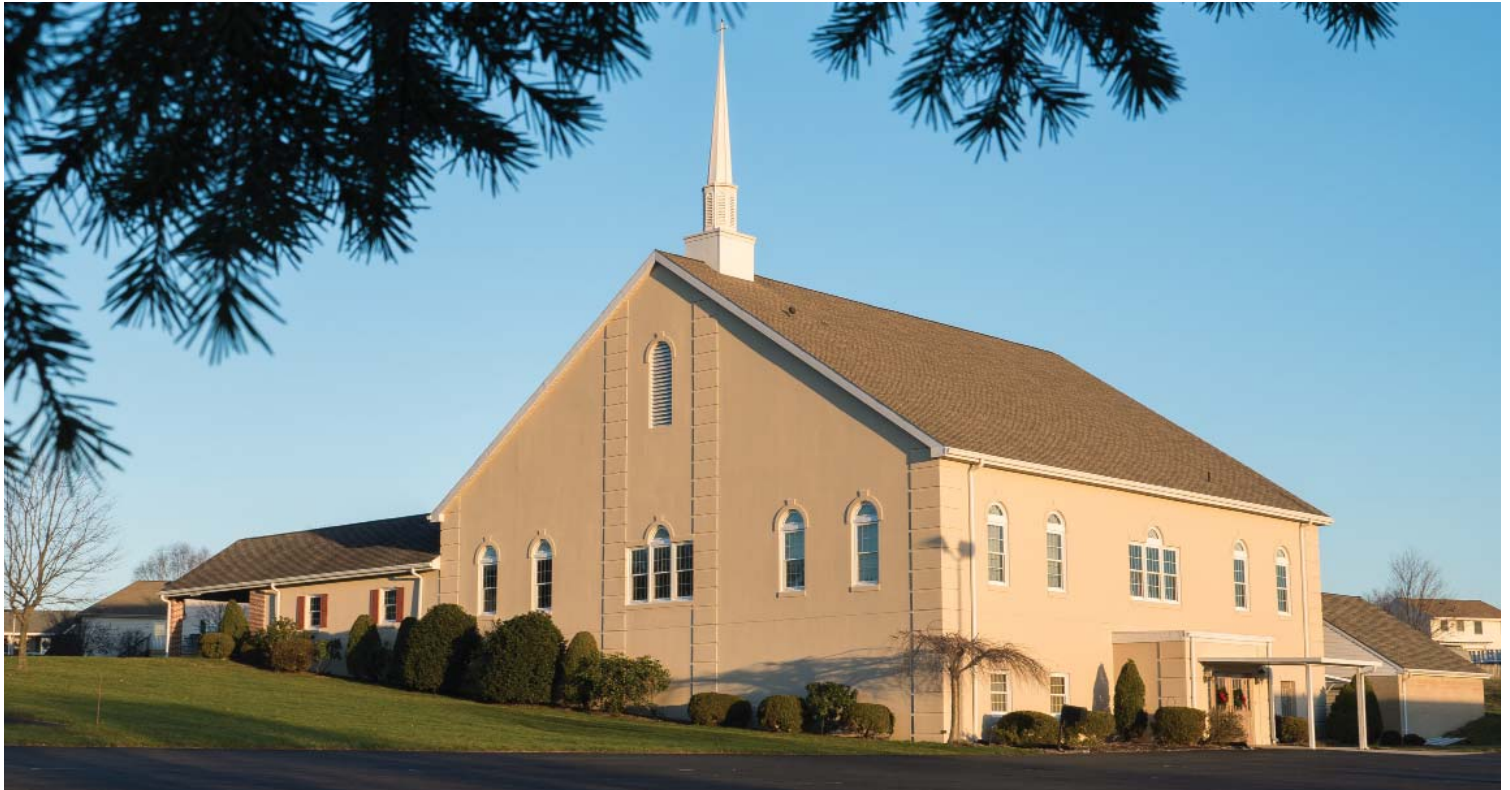
The Enola First Church of God is a beautiful multi-level building with brick veneer and large areas of Dryvit (EIFS) veneer. The EIFS areas include fancy detail trim around the windows and large quoin trims on all four corners of the main building. Years of weather exposure caused fading and hairline cracks in the EIFS finish, including severe erosion around the window details and quoins.

Witmer Coatings completed an extensive restoration of the EIFS veneer and restored the building to its original beauty and weather tight condition. The scope of work included a thorough cleaning of all EIFS areas, recaulking all EIFS joints and repairing the tops of the window details and quoins. We installed a fresh basecoat of Dryvit® Dryflex™ on all areas and also embedded new mesh in a fresh basecoat of Freestyle® and applied a new finish coat of Quartzputz™ on two of the elevations.

Finally, we applied two coats of HDPT™ paint on all EIFS surfaces to restore and blend all the older and newer materials for a beautiful and color matched finish. The Witmer Coatings team completed a stunning, high quality job, on time and without disrupting the Church's daily functions. The Church congregation will enjoy many years of beauty and service from their "like new" exterior finishes.
