PROJECT PROFILE

Luther Acres - Muhlenberg Building

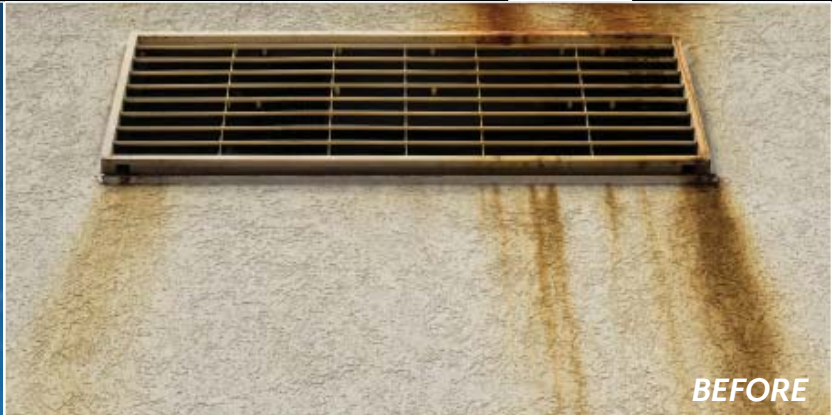
BEFORE

The exterior of the Luther Acres 165,000SF Muhlenberg Building (one of several Independent Living options in the Luther Acres 55 acre complex) had several points of repair and maintenance, including serious rust staining issues on its EIFS (Dryvit) facade due to rusting PTAC sleeves, failed caulking, and damage and weathering to the Dryvit finish in whole.

Once the 400 PTAC units were replaced, Witmer Coatings, LLC re-caulked perimeters of windows, doors and PTAC units, brick control joints, and the joints between Dryvit and brick - a total of over 30,000 lineal feet. After thoroughly cleaning the Dryvit and brick veneers (45,000LF and 35,000LF respectively), and repairing extensive damage (from lawn mower scuffs to stress cracks and falling soffits), a new commercial coating was applied that offered both protective and water repellent additives to slow future staining.
