PROJECT PROFILE

MARTIN LIBRARY

Investigative
Historic Masonry Restoration

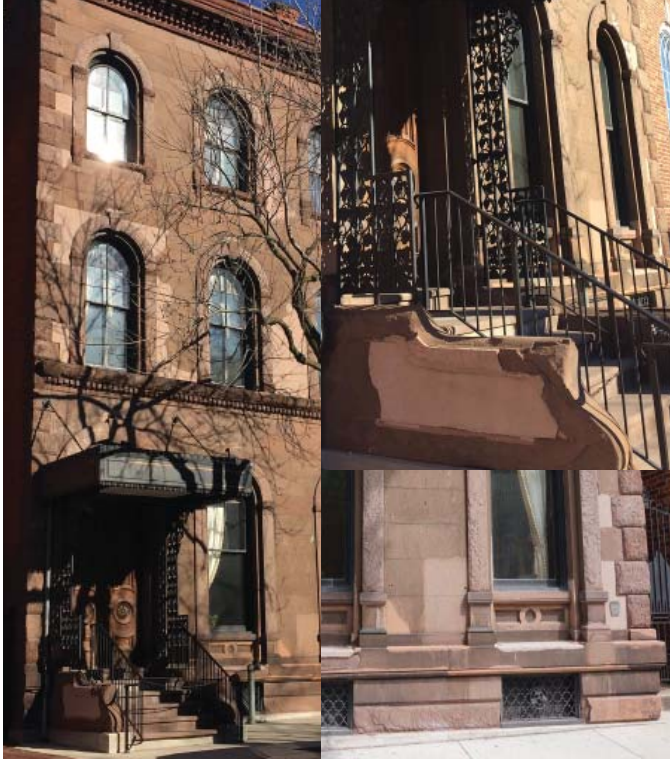
BEFORE—Weathering, age induced decline, pollutants, and acid rain has accelerated the breakdown of the veneer materials.

The exterior walls were thoroughly investigated for stability and soundness, along with calculating the extent and depth of the brownstone deterioration. Upon our investigation, we found the building to be structurally sound but rapidly deteriorating in many areas. Most of the concern included repointing of the mortar in the brownstone and brick veneers, along with the major deterioration of the brownstone veneer. Weathering, age induced decline, pollutants, and acid rain had accelerated the breakdown of the veneer materials.

Photos and documentation were taken for all brick and brownstone features to enable exact matching of replacement brownstone. All veneer pieces were properly sized for potential replacement as needed. A complete face lift of the Market Street elevation was conducted and major repointing of the east and west elevations. The Market Street elevation included the replacement of 138 pieces of brownstone in 38 different profiles, shapes, and sizes. The weight of the new brownstone pieces ranged from 8 pounds to 2600 pounds. Other tasks performed included sculpturing of original stone profiles with historic mortar materials, cleaning, repointing, and installing coatings, consolidants, and water repellents.

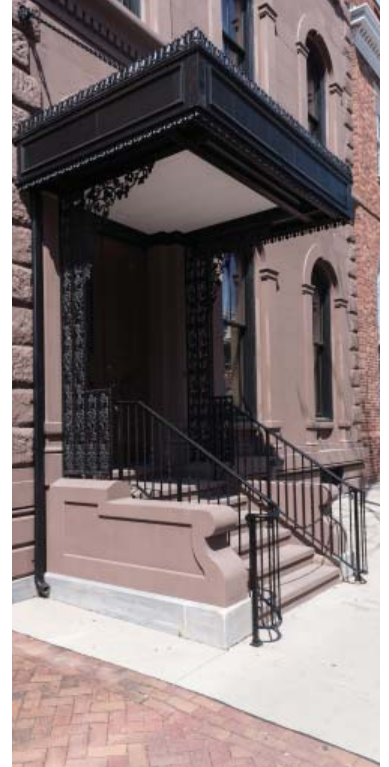
AFTER—The Market Street elevation included the replacement of 138 pieces of brownstone in 38 different profiles, shapes, and sizes.
